Abstract

Introduction

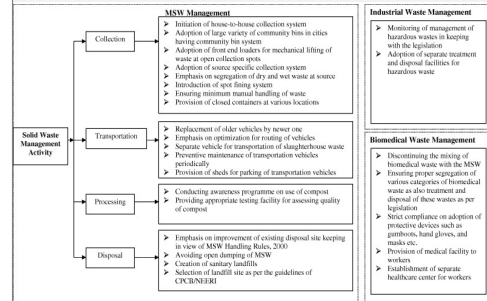
Figure 4: Flow diagram for indicative action plan for solid waste management. (8)
